Service Bulletin

21-063

9" Center Display Buzz or Ticking Sound

Year	Model	Trim Level	VIN Range
2022	Civic	Touring	ALL

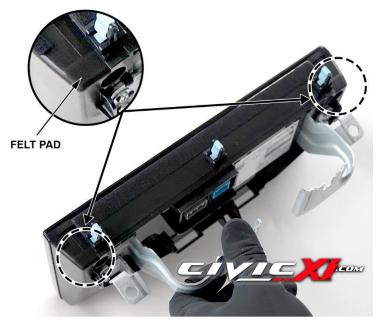
There is a gap between the center display unit and the dashboard causing vibrations.

4. Apply 5 x 10 x 1 mm pieces of felt tape as shown in the location shown on both sides, then install the center display unit.

NOTE: Make sure the felt is not visible after screen installation.
