## Outer Taillight Condensation Is Normal

All models

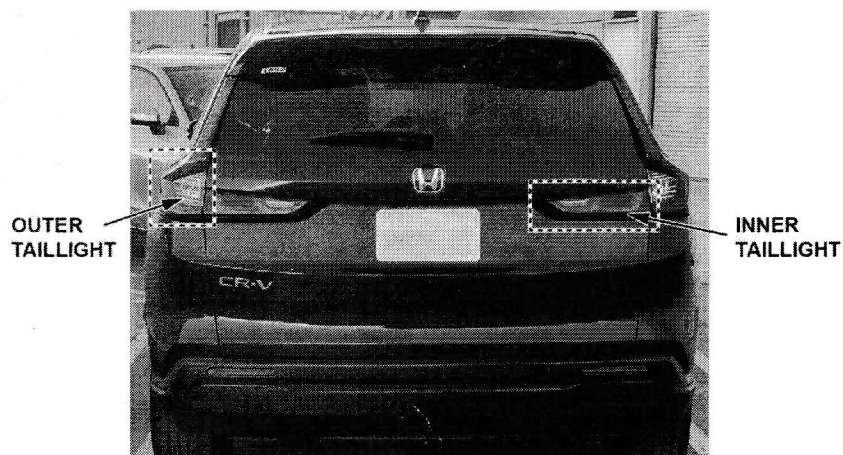
Outer taillights are designed with ventilation features which allow air to enter the taillight. When the air inside of a taillight is warmer than the air outside, condensation can form on the inside lens of the taillight. This characteristic is normal and will clear naturally.
