## Safety Recall: 2022–25 Civic Steering Gearbox Assembly

### AFFECTED VEHICLES

### BACKGROUND

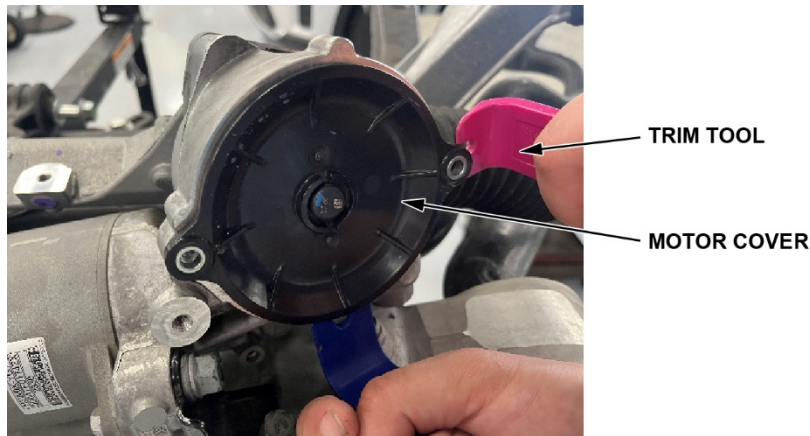
1. Remove the two bolts securing the black cover.
2. Using a plastic trim tool, gently pry the cover to separate it from the EPS gearbox. Slowly work the tool around the bottom edge of the cover to release the cover.

- **Do not** use a screwdriver or metal tool to pry the cover.
- The cover is sealed with an O-ring, which may provide some resistance.

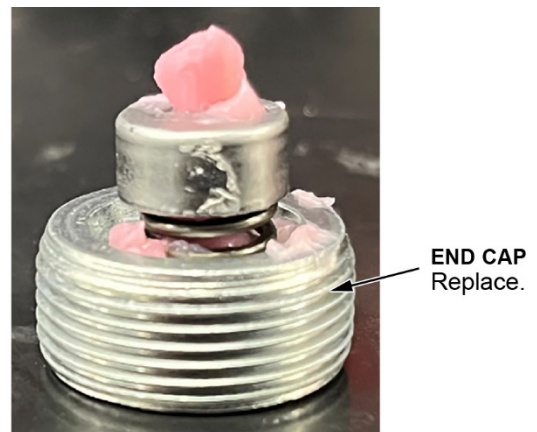
8. **Using the extra grease from the previous step**, apply grease between the new replacement end cap, spring, spring seat, and also on top of the spring seat. Protect the assembly from potential contamination by setting it aside in a safe place.

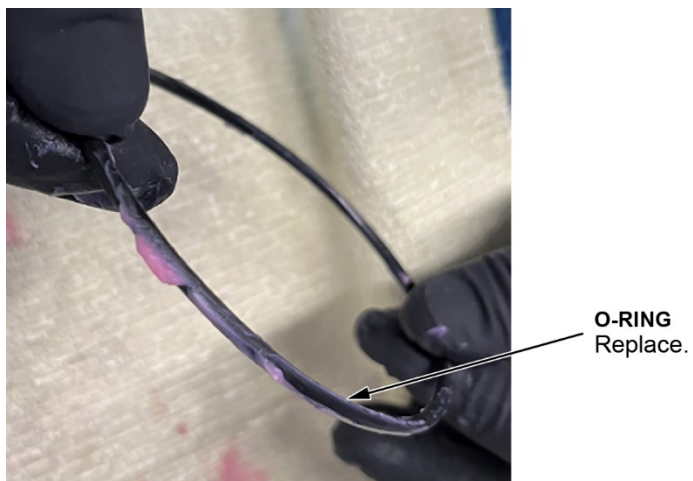
9. Apply grease to the new O-ring.

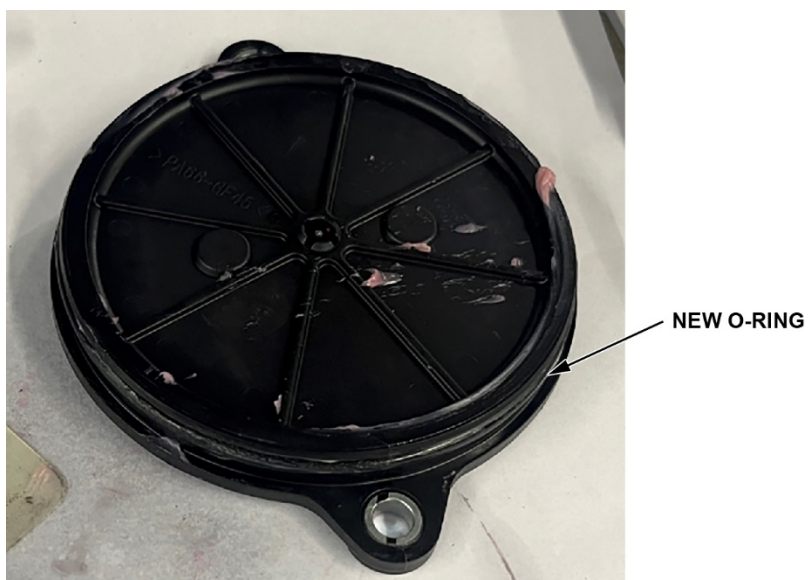
10. Install the new greased O-ring onto the cover.

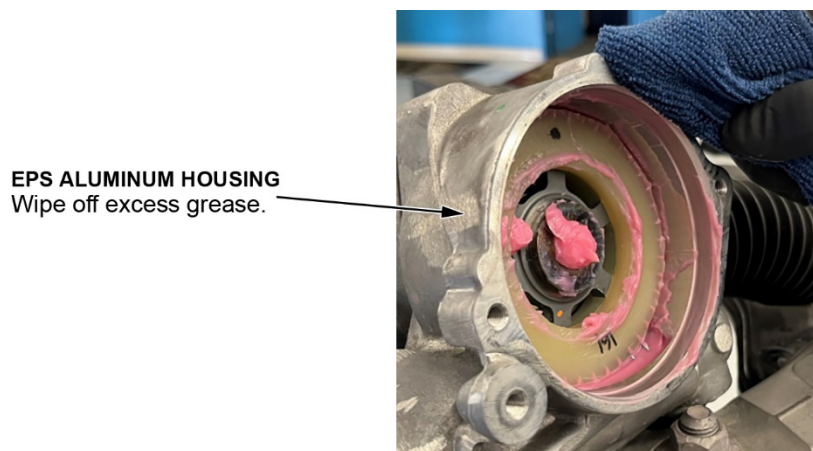
11. Wipe off any excess grease around the EPS aluminum housing.

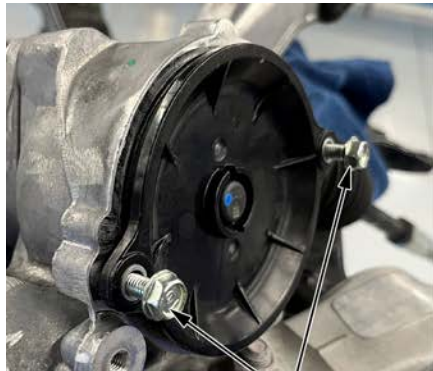
**BOLTS**  
Loosely install.

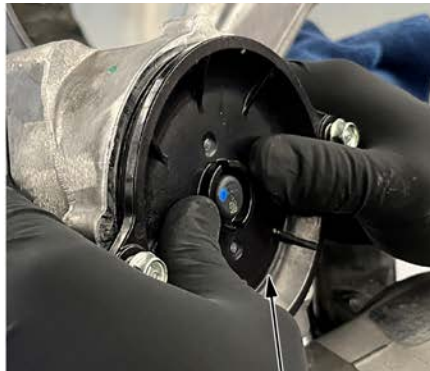
**COVER**  
Gently press.

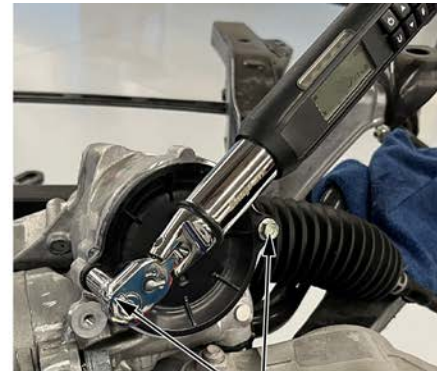
**TORQUE BOLTS**  
8 N·m (6 lb-ft)

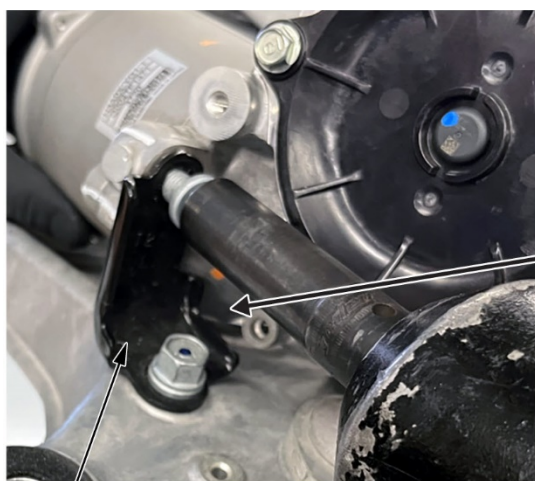
**EPS BRACKET**

13. Remove the EPS bracket.

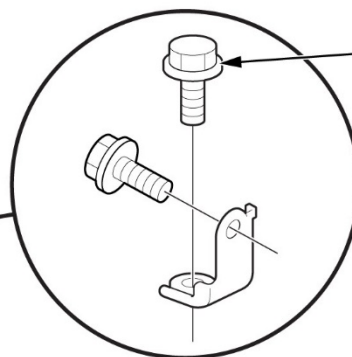
**BOLTS (2)**  
44 N·m (32 lb-ft)

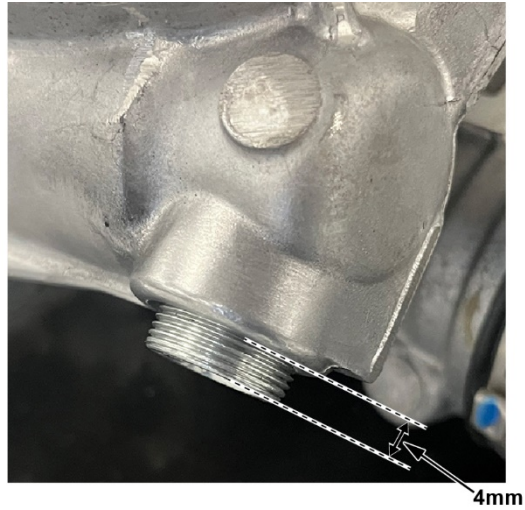
19. With the new spring seat, spring, and end cap held together by the grease, install the pieces together into the EPS gearbox, then tighten the end cap until **4 mm** of threads remain exposed.

NOTE: To keep the parts from falling off the hex socket bit while installing, rotate the EPS housing until the hole is facing downward, then install the spring seat, spring, and end cap up into the hole.

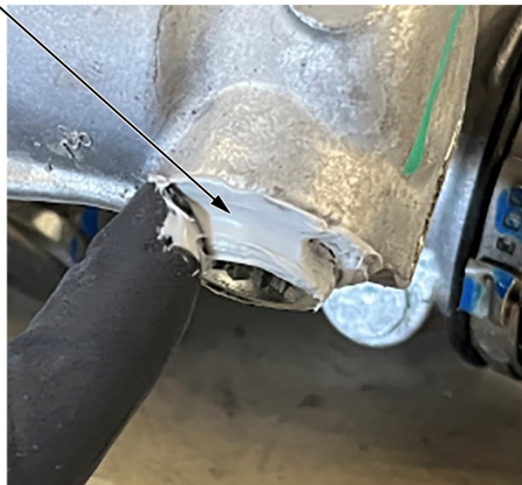
HONDABOND

20. Before torquing, apply Hondabond sealant to the exposed threads of the end cap.
