November 1, 2024

Version 6

## Safety Recall: 2022–25 Civic Steering Gearbox Repair

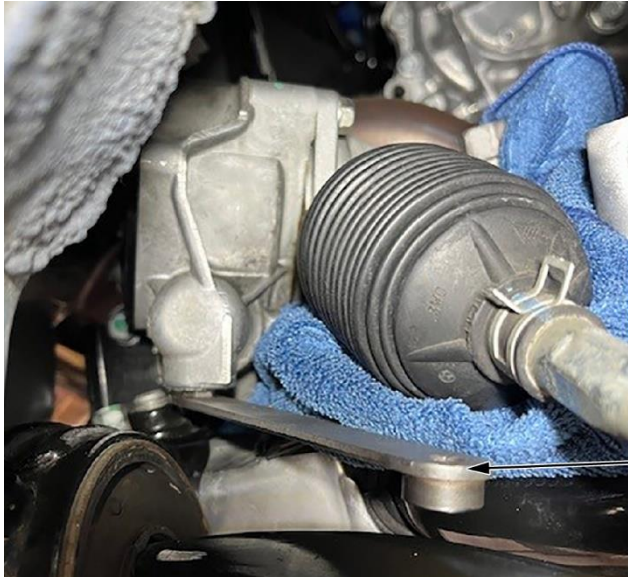
EPS PLUG  
WRENCH

8. Use the EPS plug wrench to break loose the EPS end cover plug.  
NOTE: The spring and spring seat may fall out during the end cap removal process.

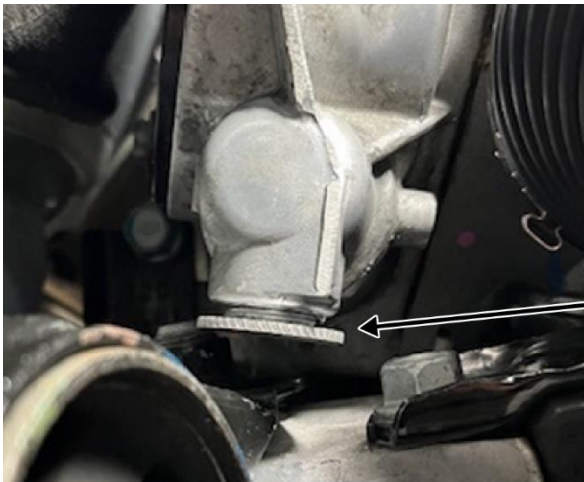
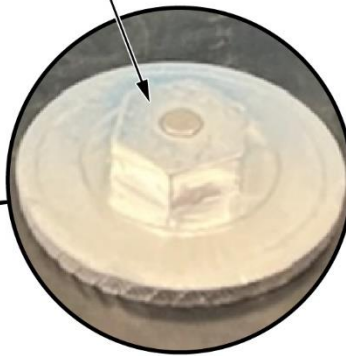
EPS PLUG  
THUMB WHEEL

9. Then use the EPS plug thumb wheel to remove the EPS end cover plug.

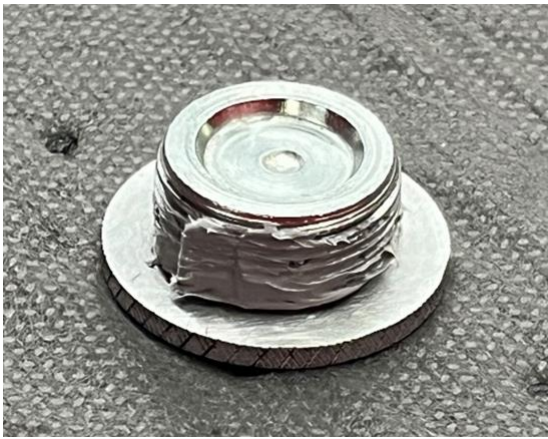
18. Apply a thin coat of Hondabond to the **NEW** EPS end cover plug threads and use the EPS plug thumb wheel to install.
